Subject: Residential Structure – Foundation Assessment
180 Britten Cove

MAE # 852323

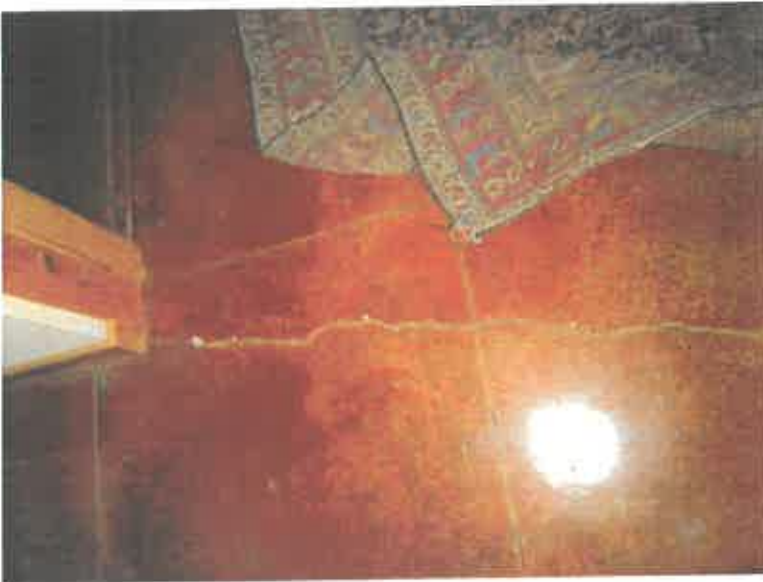
5.0 (1) There are cracks on the slab/floor in the basement utility room and hallway in the main level. Slab/ floor cracks, more often than not, are common and can be found on many homes; however, NC home inspectors are not structural engineers. Therefore, NC home inspectors cannot give their opinion on whether or not a slab crack(s) is or is not a structural concern. While foundation cracks are often typical settlement cracks, other types of slab cracks can be an indication of a larger structural concern. For this reason, and since opinions vary, I recommend further assessment by a structural engineer.

MAE's observation of the cracks in question are that they are likely the result of typical shrinkage or expansion and not a structural deficiency.

The floor surface treatment in the upstairs main level is poured and stained concrete. The crack in the main level hallway floor indicates some minor deflection on the left side of the crack, indicating that the TJI floor joist's may have deflected slightly under the weight of the concrete floor surface treatment, and near to a partition wall corner. Since the full cause of the deflection is not discernable due to concealed framing, there is no readily available remedy to repair the crack's unevenness. MAE 's opinion is that due to the minor nature of the deflection and the age of the crack, it is not of a structural concern.
